BALLOON LOGGING IN THE IDAHO BATHOLITH: A FEASIBILITY STUDY

USDA Forest Service Research Paper INT-208
INTERMOUNTAIN FOREST AND RANGE EXPERIMENT STATION,
FOREST SERVICE, U.S. DEPARTMENT OF AGRICULTURE

USDA Forest Service
Research Paper INT-208
June 1978

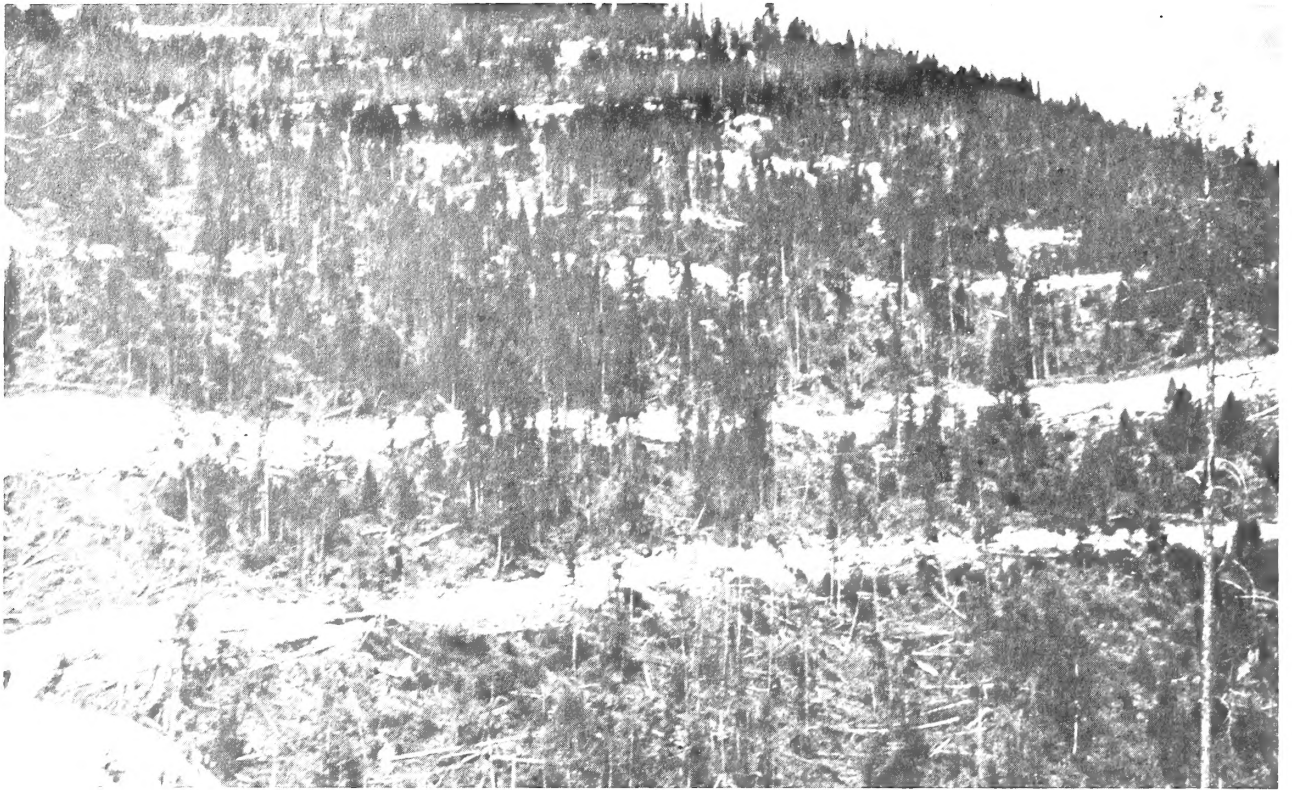
Figure 1.--An extreme example of closely spaced roads to facilitate the logging system in the Northern Batholith.

The balloon logging system proved to be an effective logging tool from an environmental viewpoint. The 3,000 ft (914 m) maximum yarding reach with this system allowed the area to be logged from existing roads. This resulted in far less damage to the logged area (Anderson Creek watershed), as compared to logging done in previous years with cat-and-jammer logging systems and the associated dense network of roads. The scars from the old logging and roads are still readily apparent, even though it has been over 20 years since much of the logging took place. Figure 1 shows an extreme example in the northern part of the Idaho Batholith of how an area looks when closely spaced roads are required to facilitate the logging method. In contrast, figure 2 shows an example of the appearance of an area shortly after being logged with the

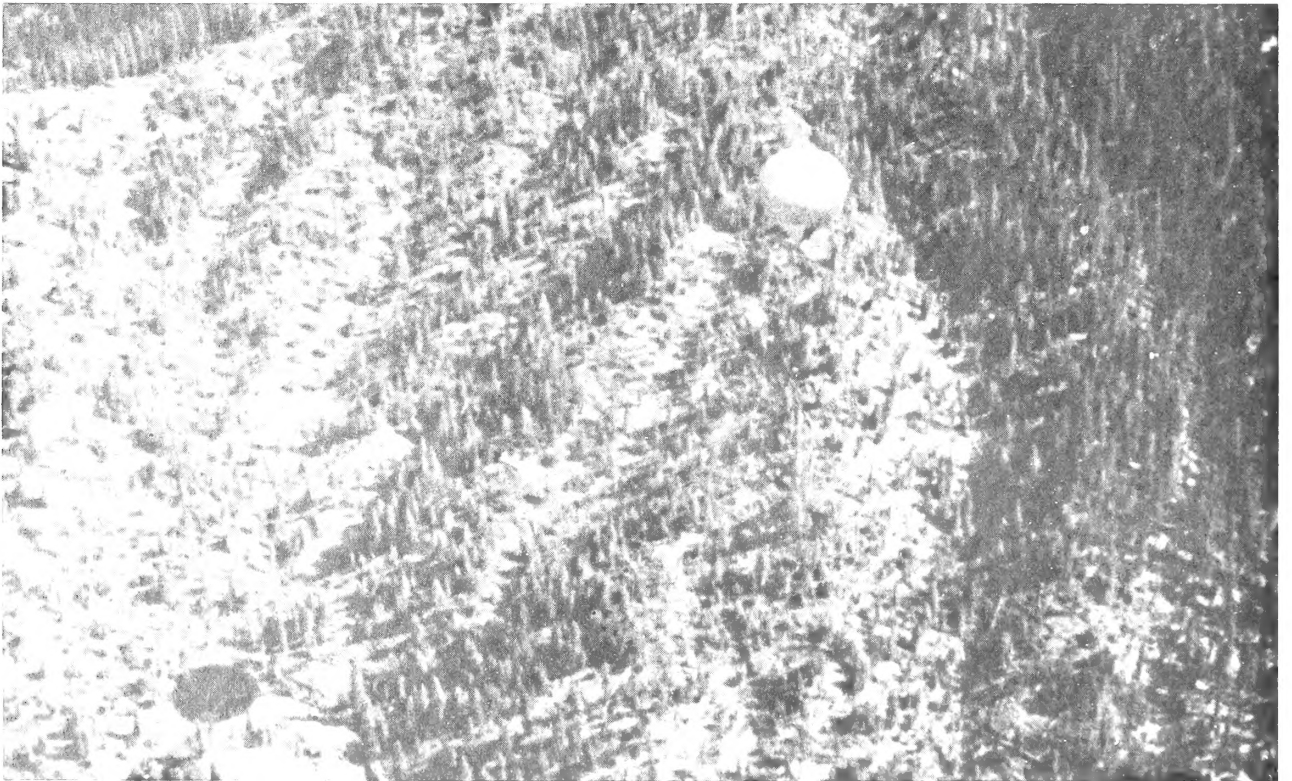
Figure 2.--An area logged with the balloon logging system.

balloon system. The esthetic advantages of balloon logging are readily apparent from the air or on the ground as there are few scars left on the landscape compared to the conventional logging methods. This visual observation has proven true at this site soon after logging and after several years have passed since the logging took place (fig. 3).

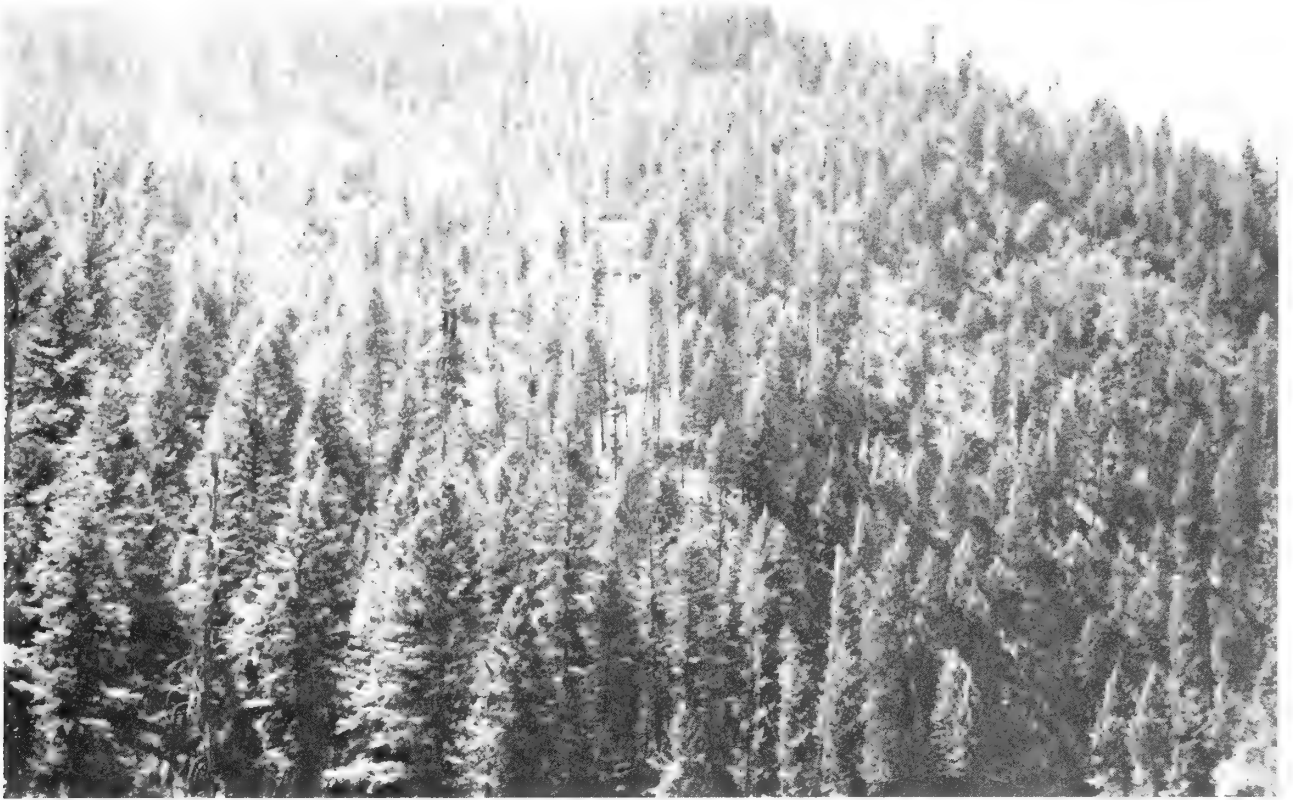
Figure 3.--Photo 5 years after the timber was removed shows very little evidence of logging.

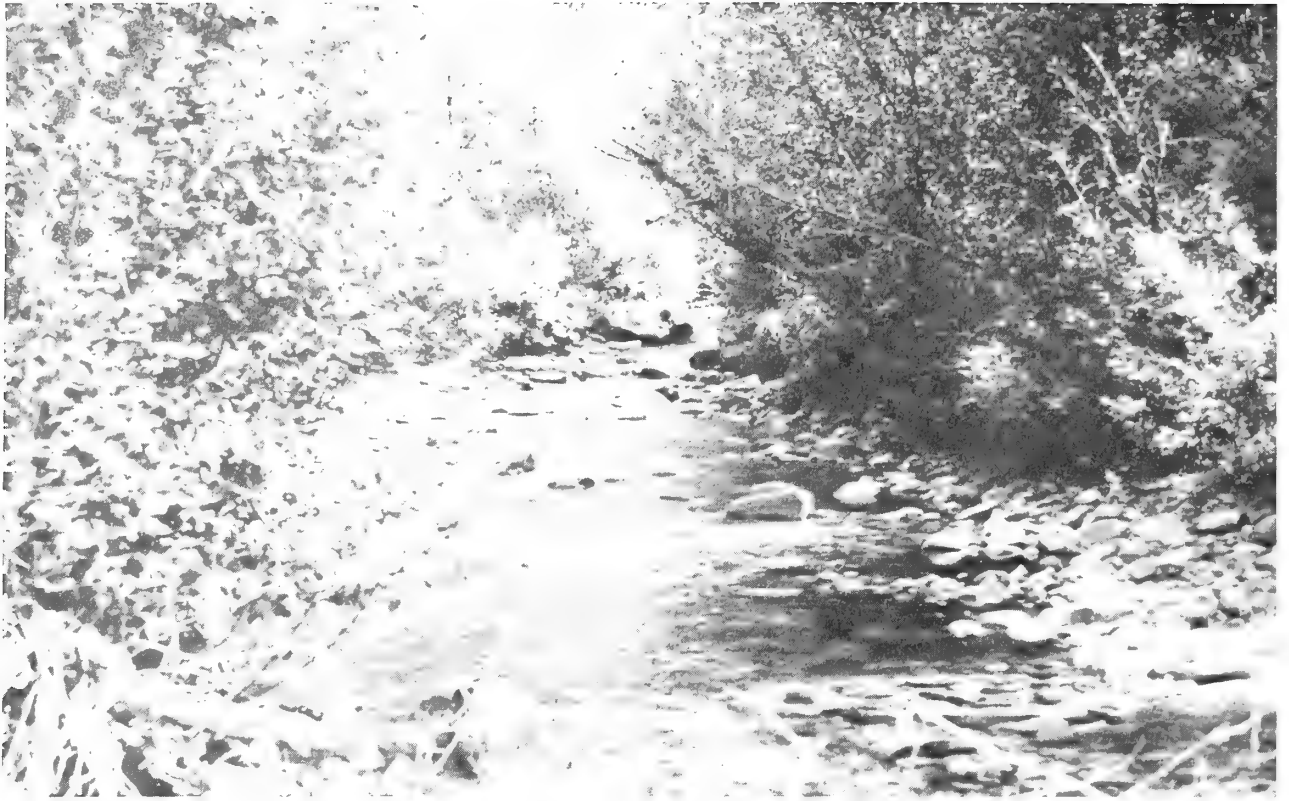
Figure 4.--In August of 1977, Anderson Creek shows little signs of logging.

A buffer strip of timber was left uncut, adjacent to stream channels in each logging unit. This was an effective method of protecting the stream, and the only apparent damage was due to a few logs being accidentally dropped into the creek during the yarding operation. Any debris from the logging was removed and the creek shows no effects from the logging. Figure 4 shows a typical reach of Anderson Creek as it was in August 1977.

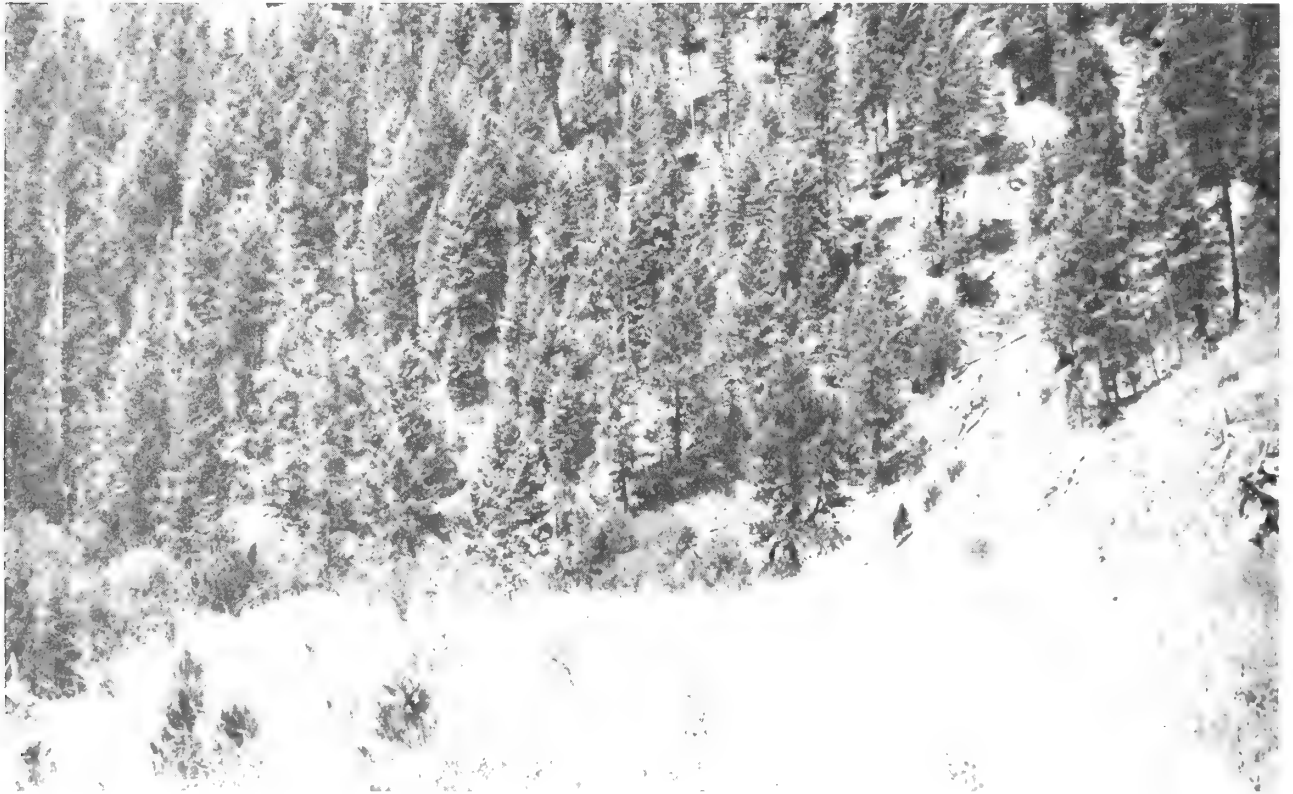
Figure 5.--Small landing areas adjacent to or on the road minimized the amount of ground disturbance.

Landing construction was a source of ground disturbance. In order to minimize this disturbance, many of the landing areas were less than one-half acre (0.2 ha) in size, or the road surface was used for a landing area (fig. 5). A bedding area (fig. 6) was constructed in the Cow Creek subdrainage for tying the balloon down during severe storms or for maintenance work on the balloon. This was the only sizable embankment constructed for the balloon logging operation, and some erosion resulted--the majority being during a high intensity rainfall shortly after construction. The gullies from the erosion have been vegetated and have stabilized as shown in figure 7.

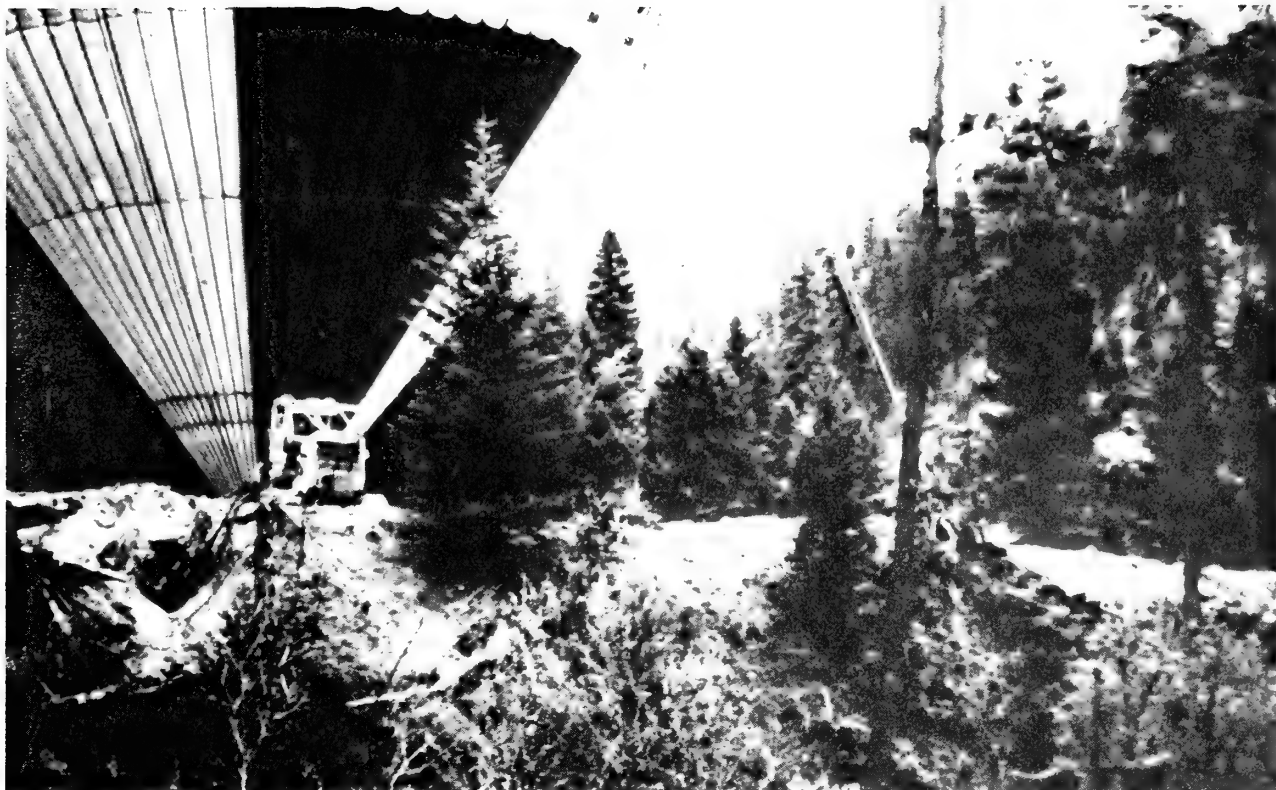
Figure 6.--Balloon bedding area in the Cow Creek subdrainage as it appeared shortly after construction.

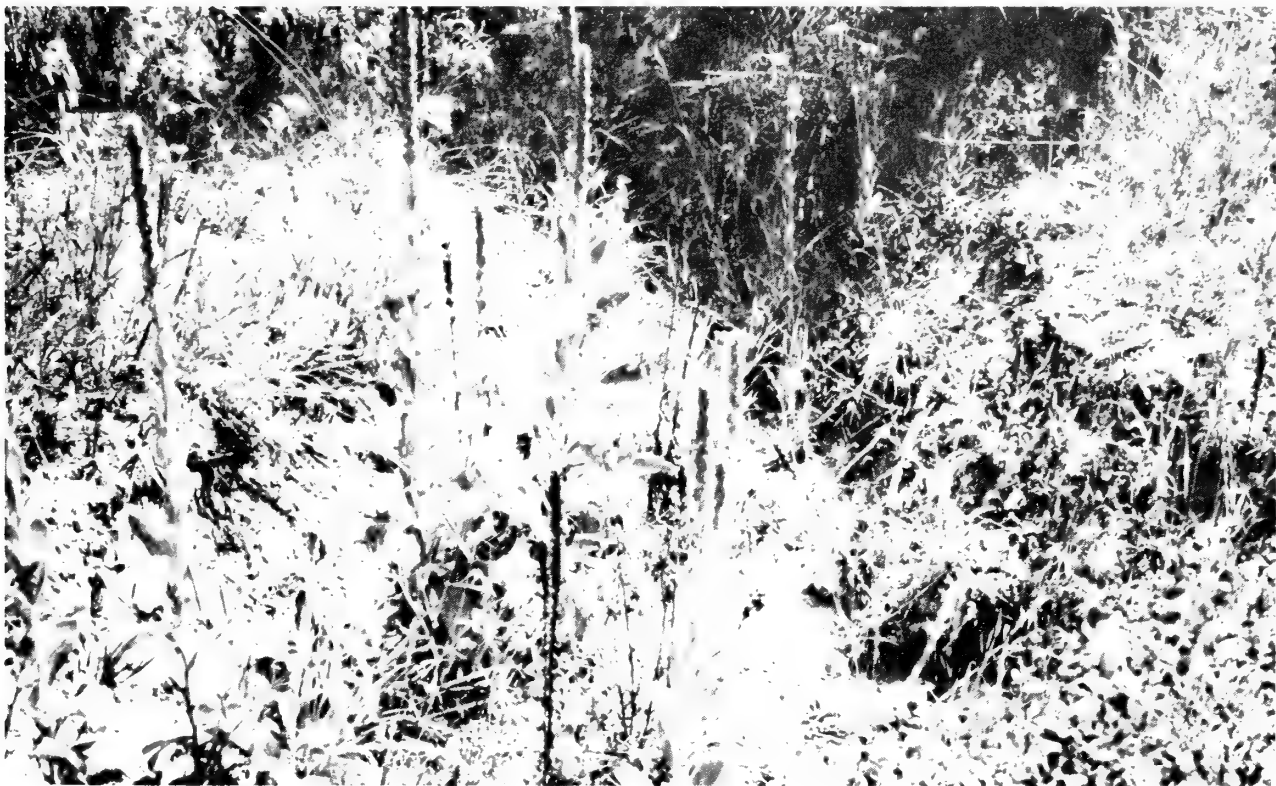
Figure 7.--Photo taken 6 years after bedding area was built shows that gullies have been stabilized and the fill banks are vegetated.

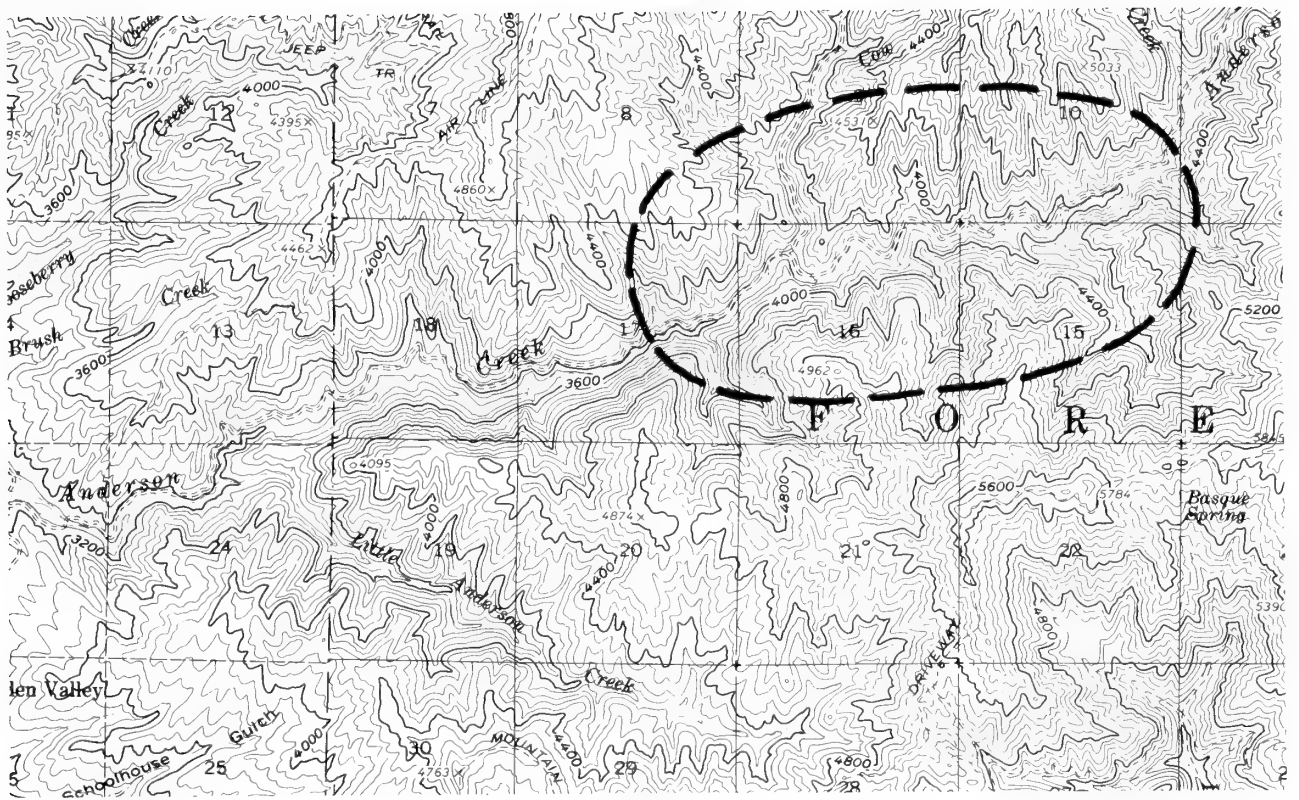
Figure 8.--Contour map of the balloon logging area in the Idaho Batholith; shows the steep and broken terrain. (Study area within dotted line.)

This sale proved the physical feasibility of logging with a balloon system in the Idaho Batholith area; however, the conditions are not ideal. Steep slopes, generally 45 to 90 percent, made working conditions difficult for the riggers, fellers, and choker setters. The highly dissected drainages made frequent cable road and layout changes necessary in order to reach the logs. Figure 8 shows the severity of the terrain on a contour map of the logged area.

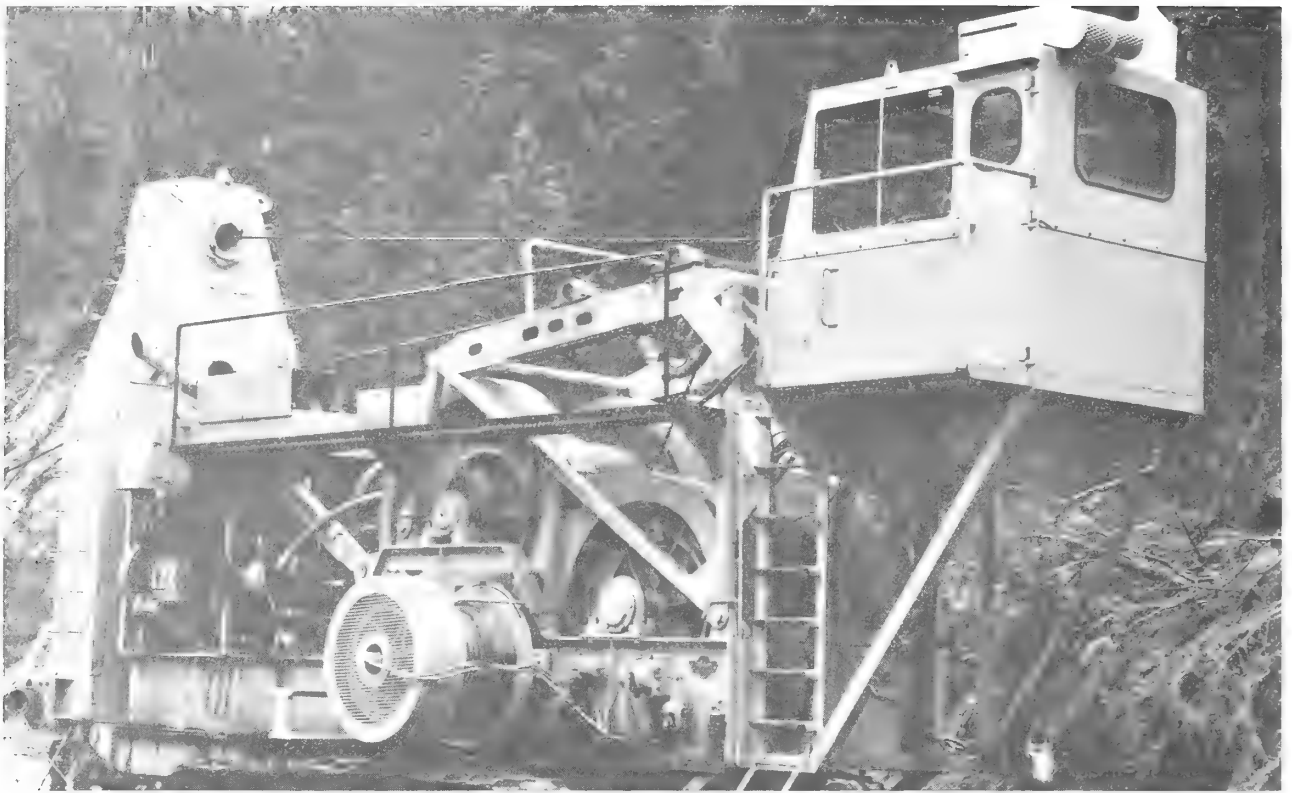
Figure 10.--Washington Model 608A yarder.

The yarder (fig. 10) was built by Washington Iron Works for the balloon logging system. Aero Yarder, Model 608A, has hydraulic interlocking drums with a mainline capacity of 5,500 ft (1,676 m) and haulback capacity of 7,000 ft (2,134 m) with 1-inch (2.54-cm) cable. The weight of the yarder is approximately 160,000 lb (72,575 kg) with a tracked undercarriage. Hydraulic problems and planetary gear problems occurred during the first year's operation, but the newly designed yarder performed satisfactorily during most of the last two logging seasons. An HD-21 tractor equipped with a large capacity hydraulic winch was used for transporting the balloon. The balloon was tethered to this tractor during maintenance and moving operations.

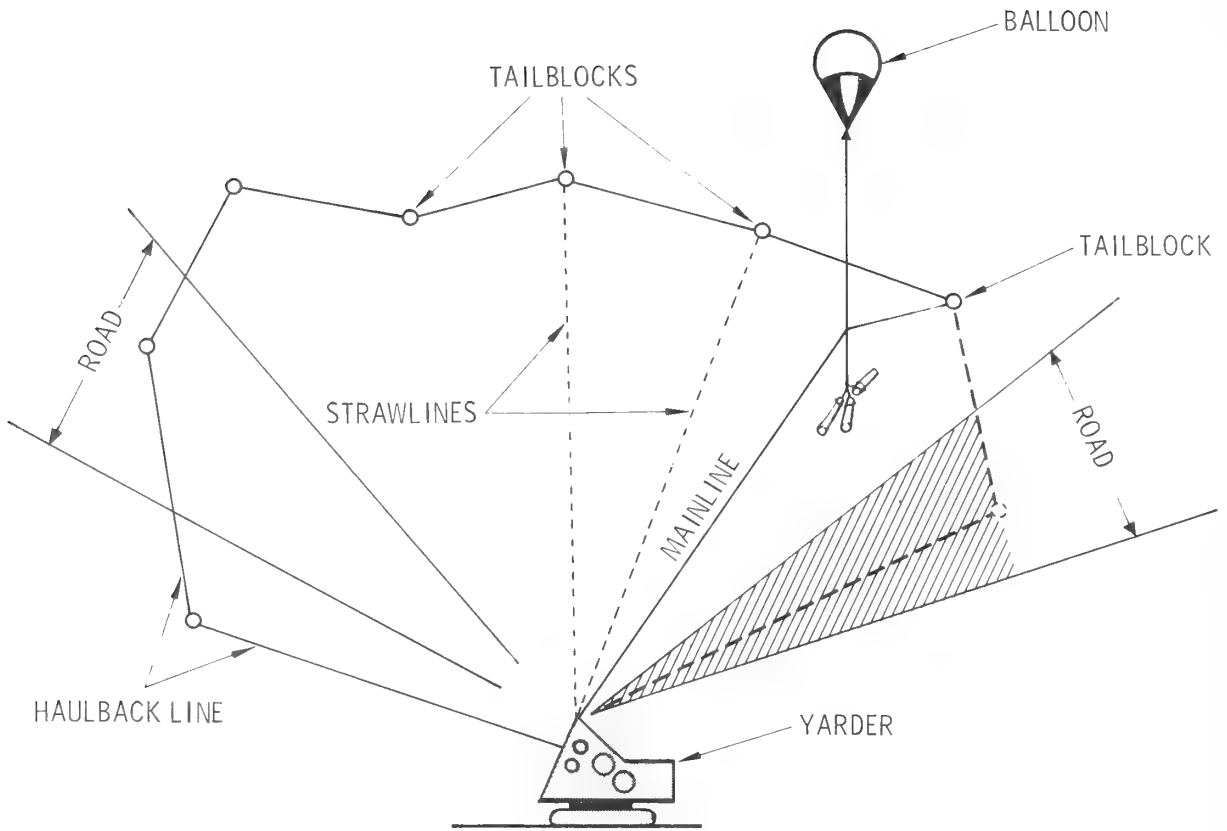
Figure 11.--Typical balloon unit and layout.

A schematic of a typical yarding layout for the sale is shown in figure 11. The figure illustrates the continuous cable system with the balloon providing a lifting force to fly logs from the stump to the landing. Location of the 5/16-inch (0.79-cm) strawline used for restringing the mainline is also shown. Figure 12 shows the operations schematic for a typical yarding turn.

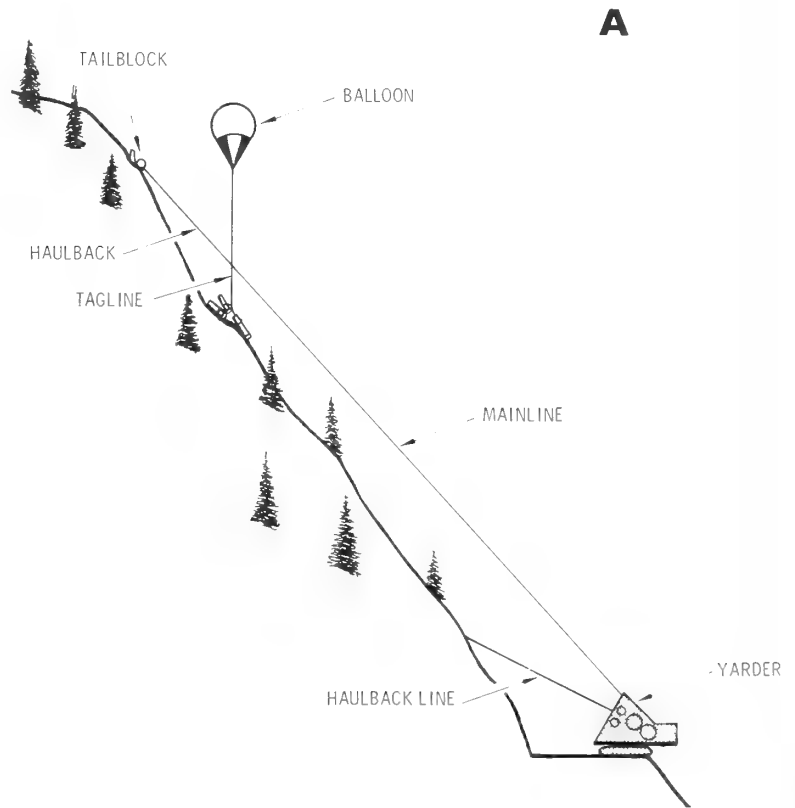
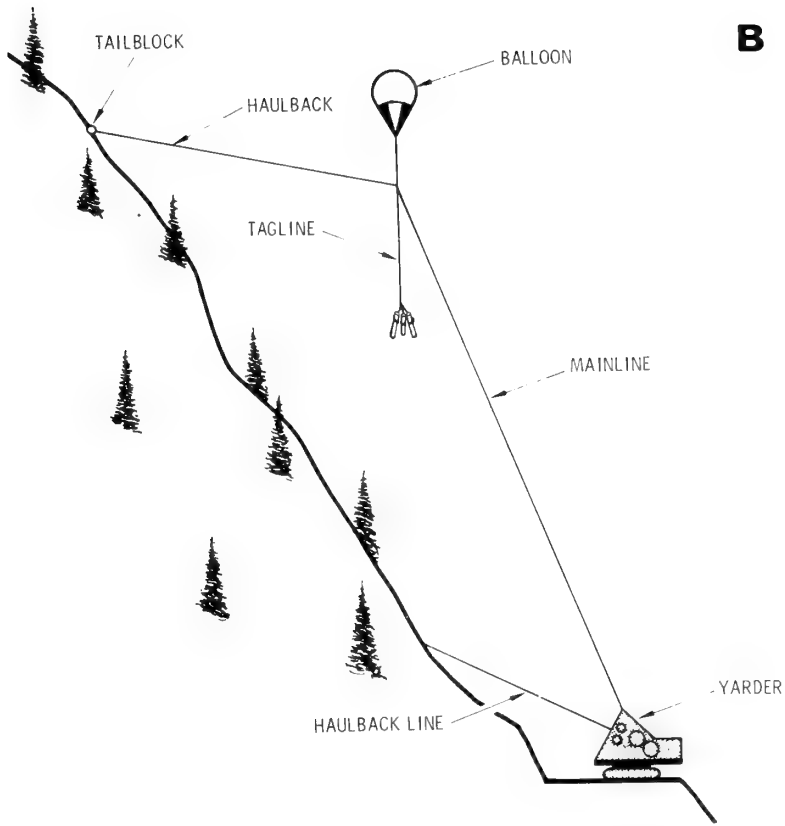
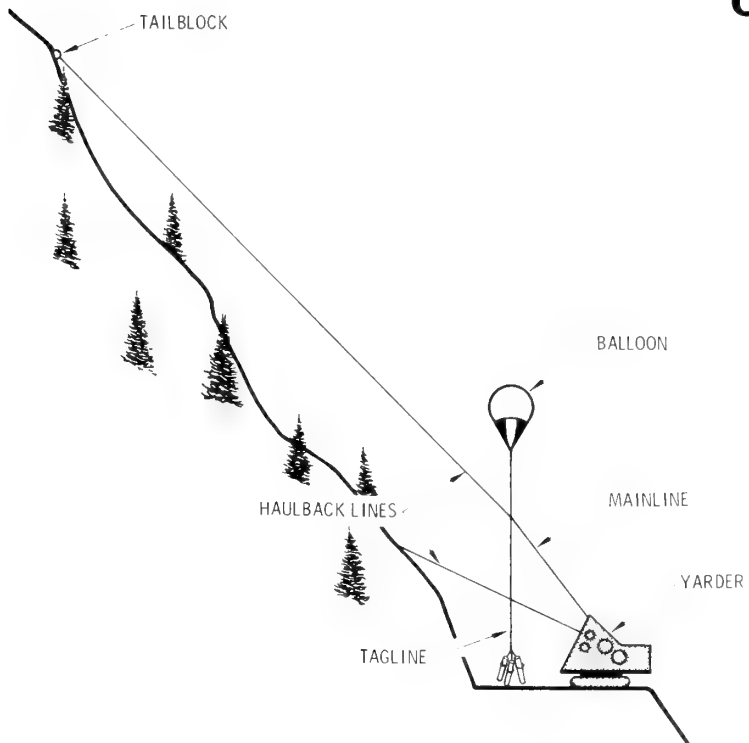
Figure 12.--Operations schematic of balloon logging system when the balloon is (A) over the logs, (B) logs are in the air, and (C) logs are at the landing.

The yarding turn starts with the balloon leaving the landing area unloaded. The balloon's buoyant force provides a portion of the power to move the system out to the felled logs. When the balloon is over the logs, tension is applied to the mainline and haulback to pull the balloon down so the tagline can be reached by the choker setters (fig. 12A). The chokers have been preset on the load of logs so that the load can be quickly hooked to the tagline and the men can move clear of the area. The choker setters then radio the machine operator that the load is hooked and ready to yard. The lines are slacked so the balloon rises nearly vertically to clear the understory and the yarder begins pulling in the mainline while simultaneously slacking the haulback (fig. 12B). As the logs approach the landing area, the rate of travel is slowed to minimize swinging of the load and the lines are tensioned in order to set the logs on the landing area (fig. 12C). The chokers are unhooked from the logs and flown back to the choker setter as the cycle starts again.

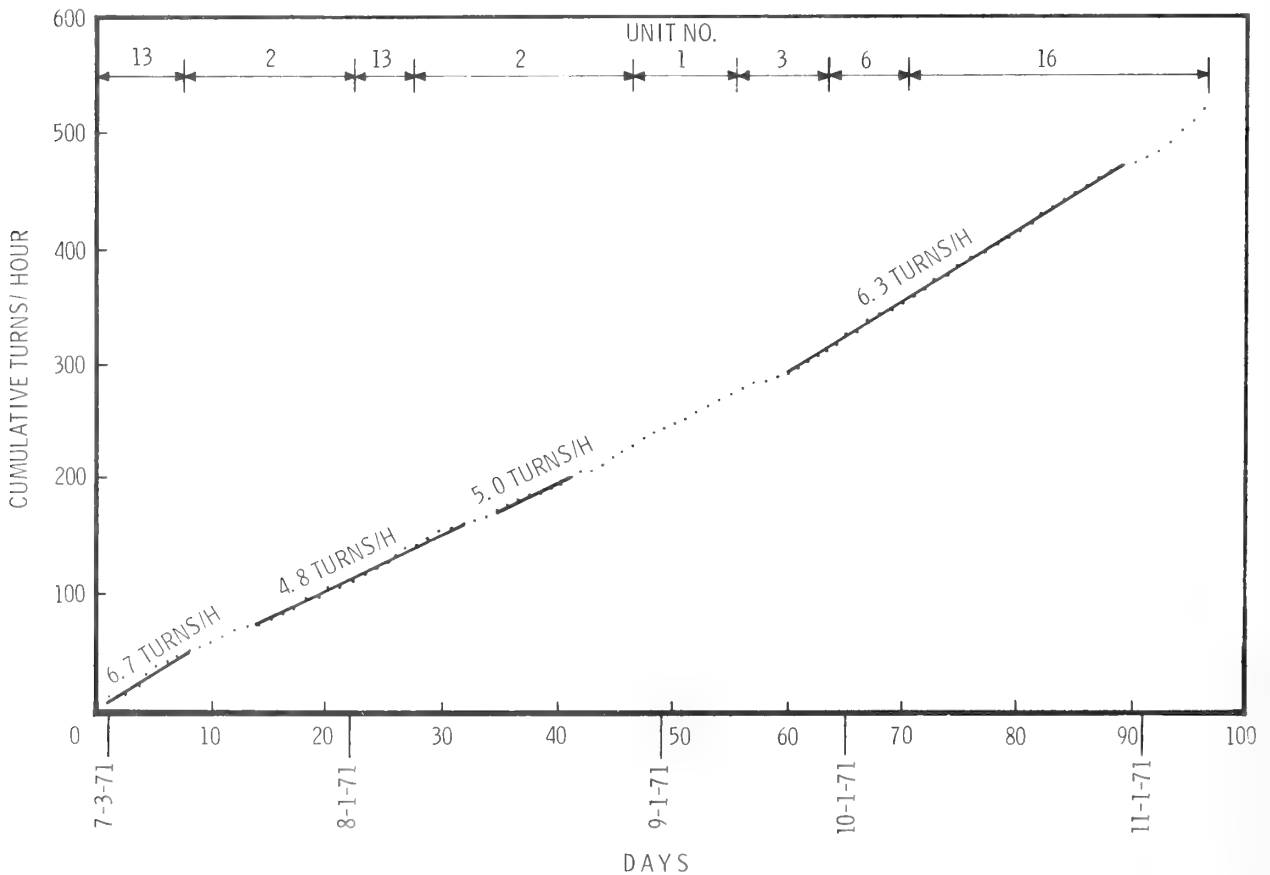
Figure 13.--Turns per productive hour (cumulative) vs. date, unit.

The first step in the economic analysis was to plot production per hour versus time in days to see if a learning period could be identified during the startup of the system. Cumulative plots of turns per productive hour (fig. 13) and pieces per productive hour (fig. 14) were used because of the high variability in daily production rates. The slopes of the line segments on the graphs indicate that production rates were not time dependent. This is not surprising in view of the circumstances involved on this timber sale. Boise Cascade had sent the crews to another balloon logging job on the West Coast to be trained for the balloon system of logging. Operators were selected that had experience on similar equipment used for cable logging. Supervisory personnel from Bohemia Logging Company (a company with several years of experience with balloon logging) were on hand during the startup and initial shakedown of the system.

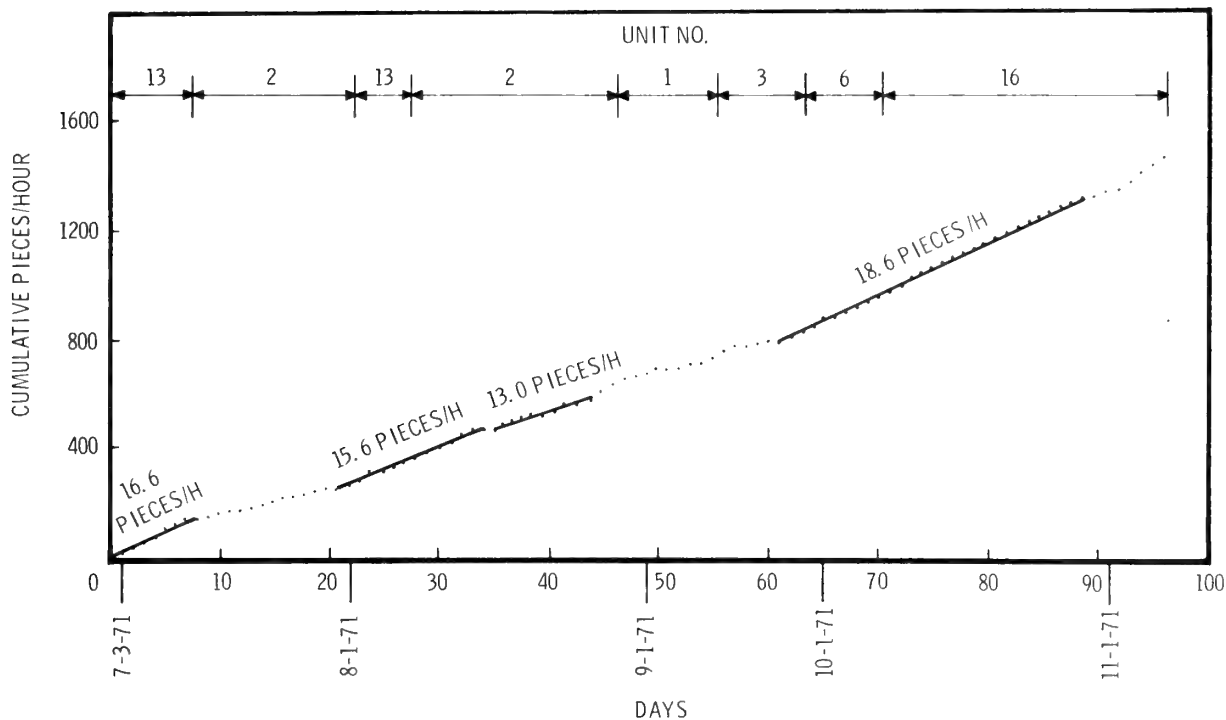
Figure 14.--Pieces per productive hour (cumulative) vs. date, unit.
